Intertidal habitat mapping for ecosystem goods and services: Waikato estuaries

Intertidal habitat mapping for ecosystem goods and services: Waikato Estuaries

Prepared for Waikato Regional Council

NIWA Client Report No:	HAM2013-085
Report date:	September 2013
NIWA Project:	EVW13217/8

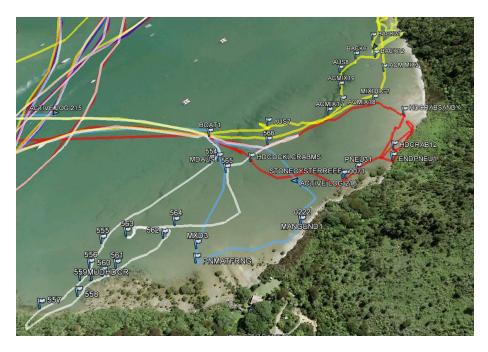
Figure 2-2: Transects walked by four personnel in fan formation, used for long narrow bays to maximise coverage.

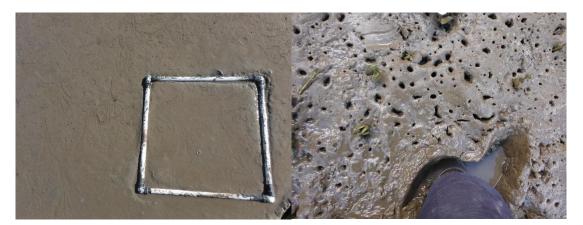
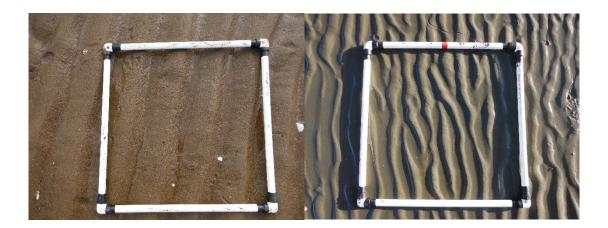
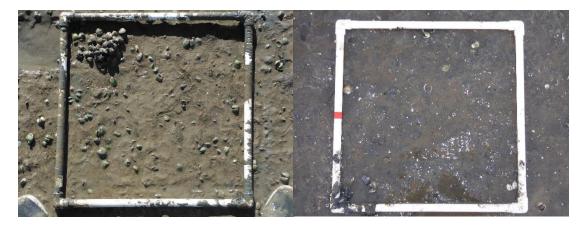
Figure 2-3: Example of the sediment types: mud (top), sand (middle) and sandy mud/muddy sand (bottom).

Observations were made of sediment types to place intertidal areas into one of 5 nonoverlapping categories (Figures 2-3 and 2-4):

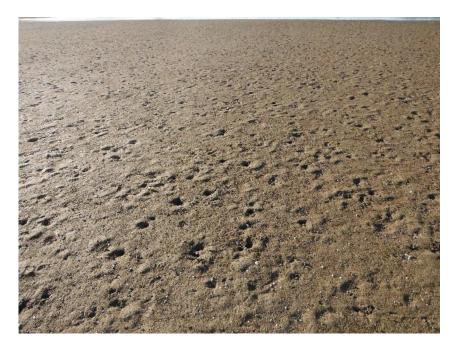
Figure 5-2: High frequencies of small ray pits in the western bays of Whangamata could be mistaken for burrows.

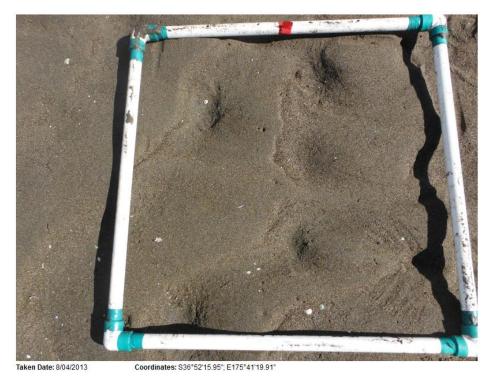
Figure 5-6: Sandy sediment in the upper reaches of Whitianga Harbour.

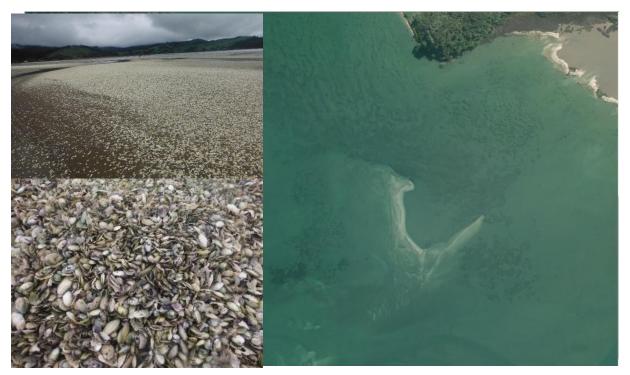
Figure 5-13: The shell bank found in Brickfield Bay. Seen as the white outline in the centre of the picture (right). The bank is comprised of pipi and some cockle shells (left).

- Coromandel Harbour has extensive intertidal flats and is host to many mussel and oyster farms.
- The large shell bank in Brickfield Bay is migrating shoreward (Figure 5-13).
 Google Earth images show that it has moved approximately 60 m since 2001; equating to a rate of ~5 m y⁻¹.
- Intertidal oyster farms have altered flow dynamics and facilitated silt and mud accrual in the surrounding areas (Figure 5-14).

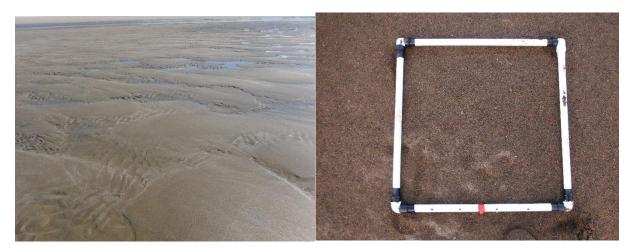
Muddy sand (left) and mud (right) examples of crab dominated habitat.

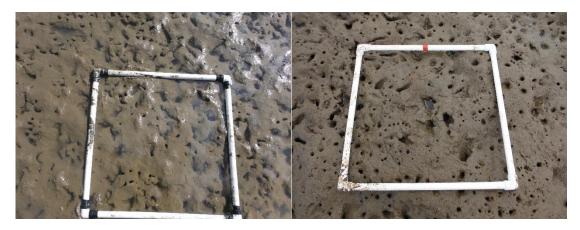
Typical 'LD deposit feeder' habitat of muddy sand with a mixture of deposit feeding worms and shellfish.

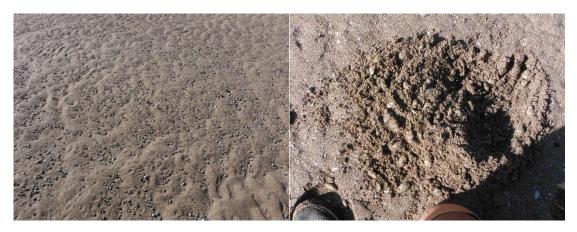
Coarse sand with cockles exposed from physical reworking (left) and high densities of pipi in sands near to the harbour mouth.

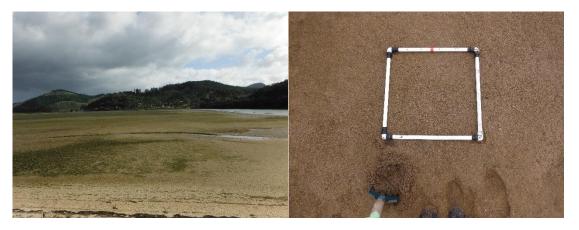
Seagrass patches in the central section of the harbour (left) and sand with low levels of macrofauna (low-bio habitat) (right).

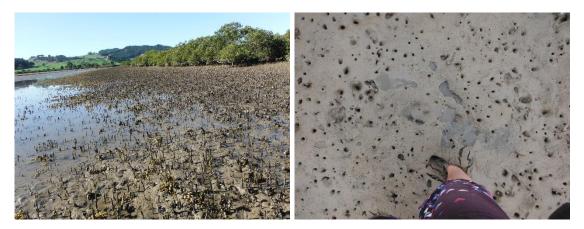
Muddy sediments with pneumatophores and sparse oyster reef attached (left) and crab habitat (right).

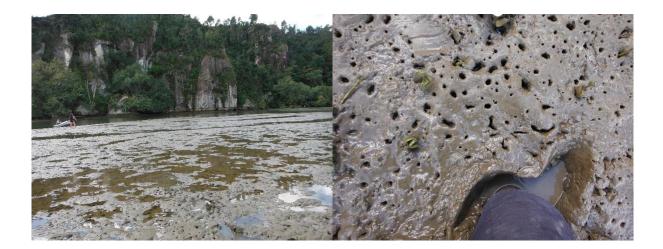
Large areas of the intertidal are dominated by crab habitat (with high burrow densities m⁻²) in the lower sections of the Whitianga Harbour. Sediments here can be very deep mud (>knee deep).

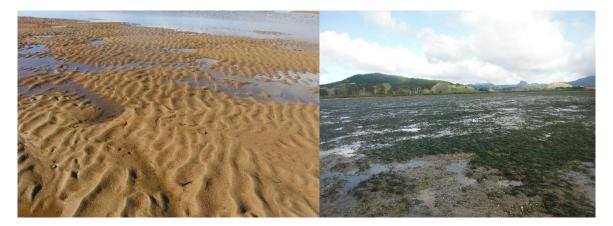
'Low bio' habitat with few organism present and high levels of physical sediment reworking evident from surface topography (left). Seagrass habitat from the lower section of the Harbour.

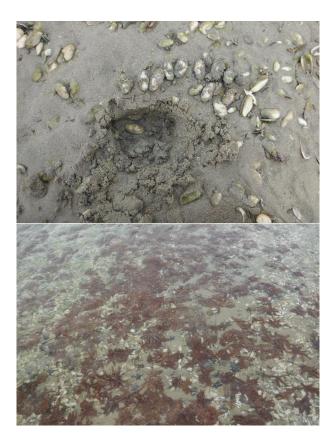
Pipi habitat from the left-hand-side of the Harbour mouth (left). Evidence of Asteroidean scavenging/predation on the pipi habitat evident in the shallow subtidal.

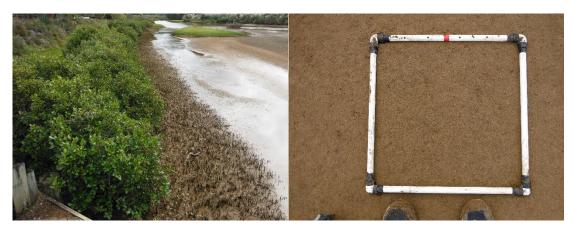
Mangrove and pneumatophore habitats in Kennedy Bay (left) and 'low bio' habitat with few organism present (right).

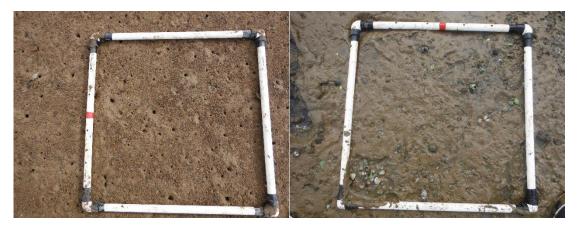
Crab habitat with coarse riverine deposits/gravel on the sediment surface (left). Isolated pockets of sandy mud sediment with high densities of cockles (right) from the shorter arm of Kennedy Bay.

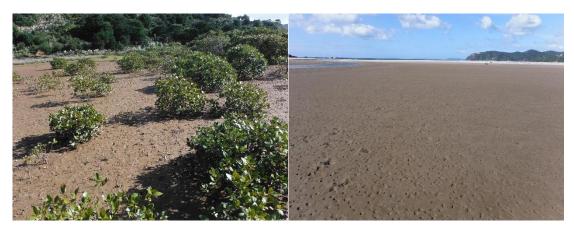
Mangroves from the upper reaches of Waikawau Bay (left) and sediment with pitted marks evident on the surface from the mid harbour section.

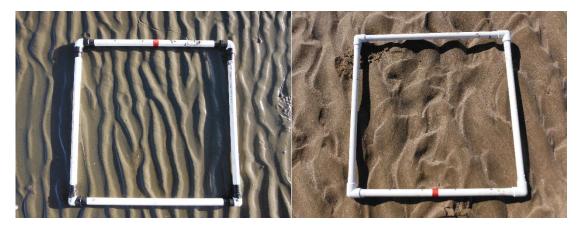
Physically dominated sands cover a large proportion of the Colville bay area (left and right).

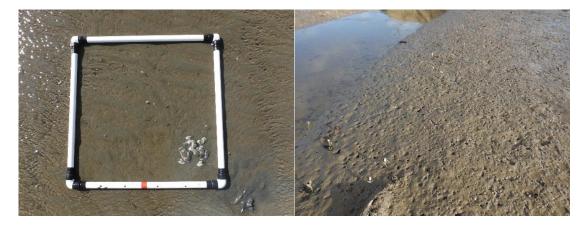
Pipi habitat is presence (left). Areas close to the drainage channels show evidence of mud accumulation and associated fauna i.e., crab habitat (right).

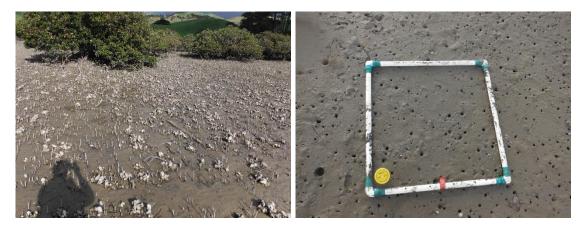
Mangroves and pneumatophore habitat (left) with oyster reef attached. Crab habitats dominate near many of the channels (right).

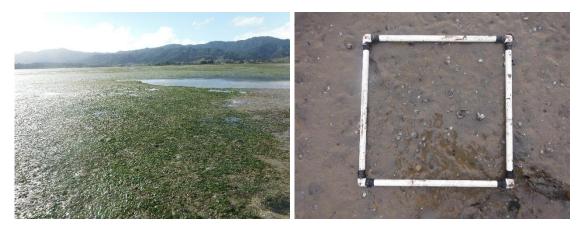
Large patches of seagrass habitat are found shoreward of the oyster farms in Brickfield Bay (left). Around seagrass patches and in other areas cockle habitats dominate (right).

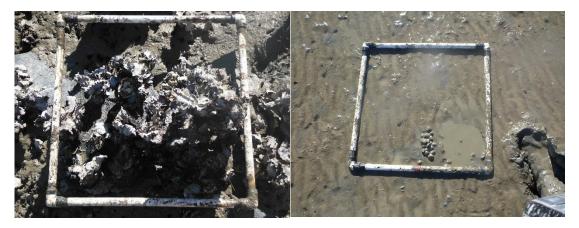
Oyster reef on the fringing rocks around the harbour (left). Mud accumulation associated with the oyster farm is evident and results in high mud fractions shoreward of it. Shellfish still persist and are found here i.e., cockle habitat (right).

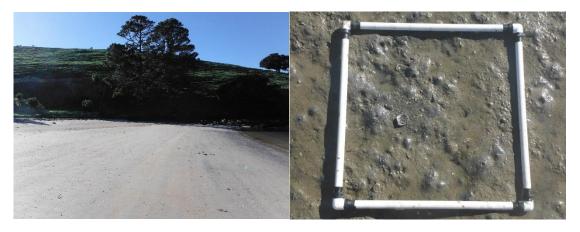
'Low fauna' habitat from the most exposed outer Bay in Te Kouma Harbour (left). 'low density deposit feeder' habitat (right).

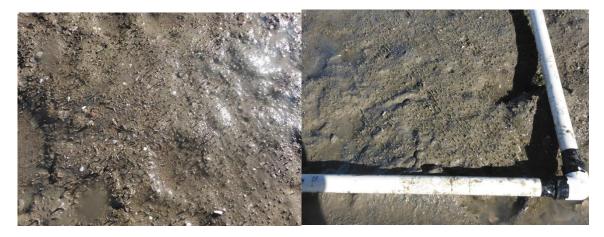
Tubeworm and crab habitats evident from the mid bays in Te Kouma Harbour (left and right)

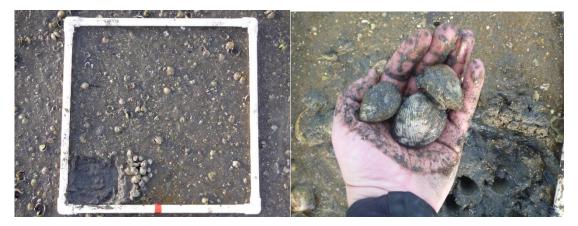
A typical cockle habitat with a high density of individuals (left). Also patches with extremely large individuals (>40mm length) but generally at low density (right). These were incorporated in to the HD cockle habitat.

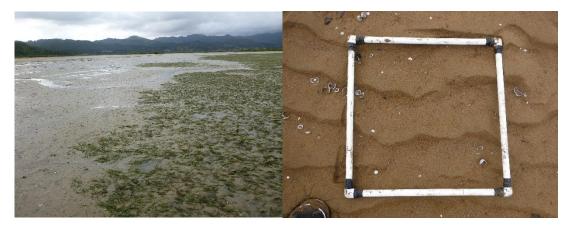
Seagrass habitat patches present throughout the harbour (left) and 'low fauna' habitat close to the main harbour channel (right).

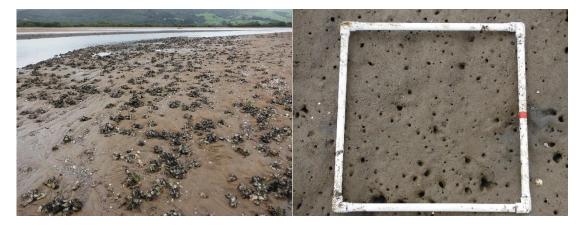
Scattered oyster reef sits on top of the sandy sediment surface (left) and a muddy sand contains a high density of crab burrows (right).
